# Arroyo Mocho Stanley Reach Stabilization Project – Construction Progress Report

November 8, 2021 – BAFPAA Monthly Meeting

Jeff Tang, Project Engineer

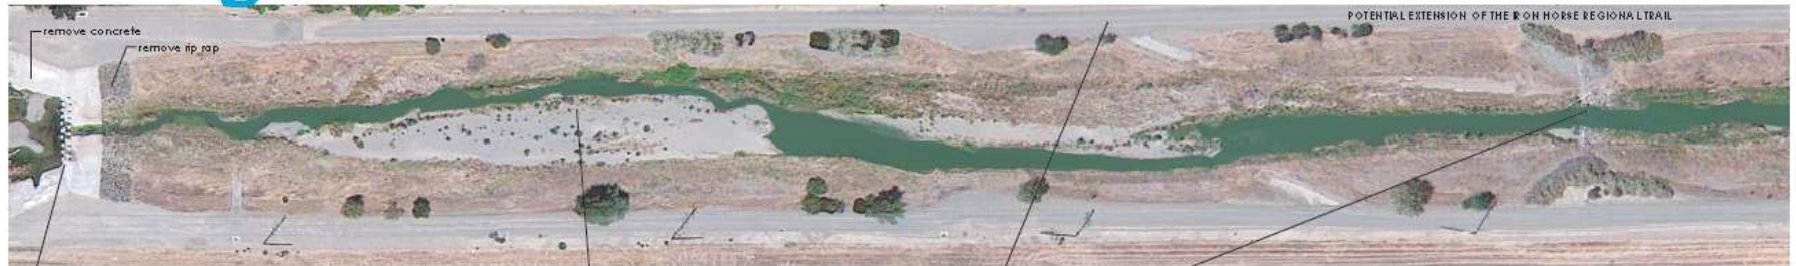
BEFORE

DRA GON'S TEETH CREATE A PHYSICAL AND VELOCITY BARRIER TO MIGRATING FISH

DEMOLISH DRA GON'S TEETH AND REPLACE WITH ROUGHENED CHANNEL

WILLOW BAFFLES INSTALLED TO INCREASE ROUGHNESS, PREVENT SCOUR, AND INTRODUCE TOPOGRAPHIC VARIABILITY

LITTLE TO NO CANOPY COVER TO SHADE STREAM LEADING TO ELEVATED STREAM TEMPERATURES

NEARLY 7,000 TREES PLANTED TO PROVIDE MULTIPLE GEOMORPHIC, HABITAT, AND AESTHETIC BENEFITS

NO CURRENT PUBLIC ACCESS AND LITTLE AESTHETIC VALUE FOR RECREATION OR COMMUNITY AMENITIES

GRADE CONTROL STRUCTURES CREATE A PARTIAL PHYSICAL AND VELOCITY BARRIER TO FISH

REMOVE CONTROL STRUCTURES, ELIMINATE CHANNEL CONSTRUCTIONS, AND REGRADE CHANNEL

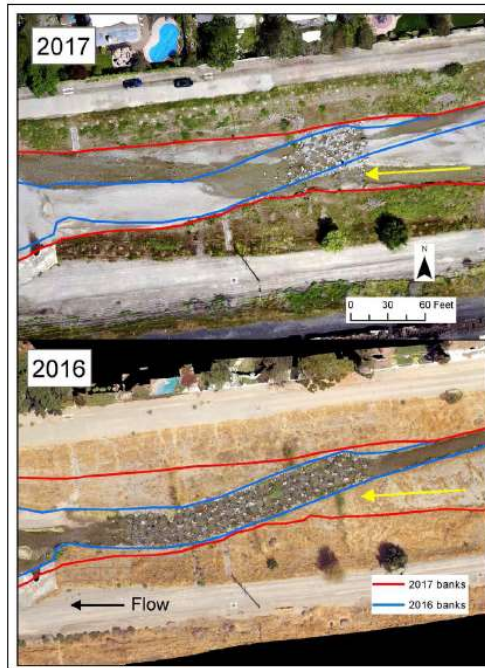
**SITE 1**  
Roughened  
Channel #1  
(downstream)

Stanley Reach Monitoring & Assessment - D160463.10  
SOURCE:ESA 2017  
**Figure 5**  
Comparison between ground conditions in 2016 and 2017  
Downstream Roughened Channel (Sta 25+15 to 28+15)

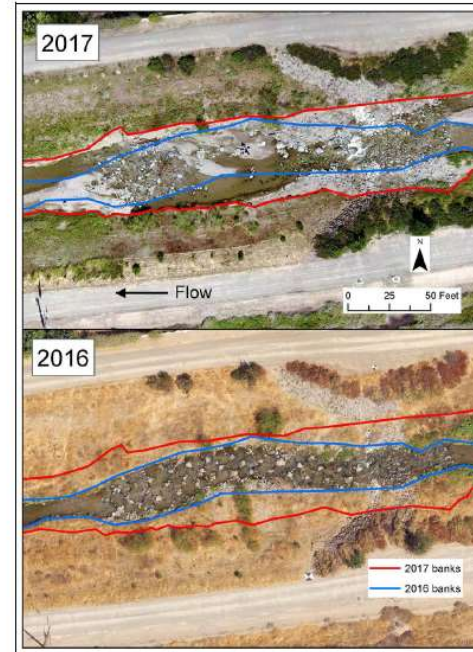
**SITE 2**  
Roughened  
Channel #2  
(upstream)

Stanley Reach Monitoring & Assessment - D160463.10  
SOURCE:ESA 2017  
**Figure 4**  
Comparison between ground conditions in 2016 and 2017  
Upstream Roughened Channel (Sta 37+90 to 41+30)

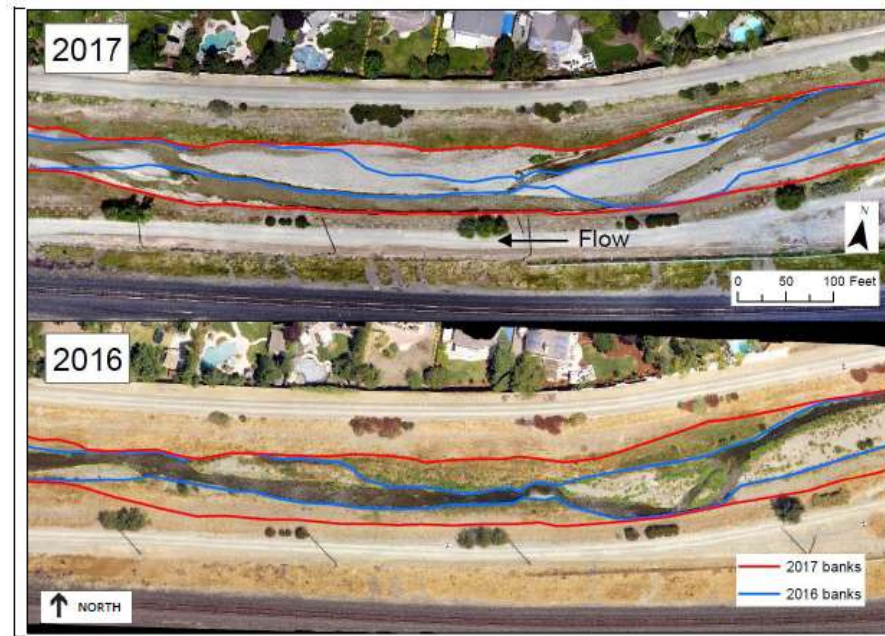
**SITE 3**  
Upstream  
bank  
retreat

Stanley Reach Monitoring & Assessment . D160463.10  
**Figure 3**  
Comparison between ground conditions in 2016 and 2017  
Upstream Reach (Station 56+00 to 66+00)

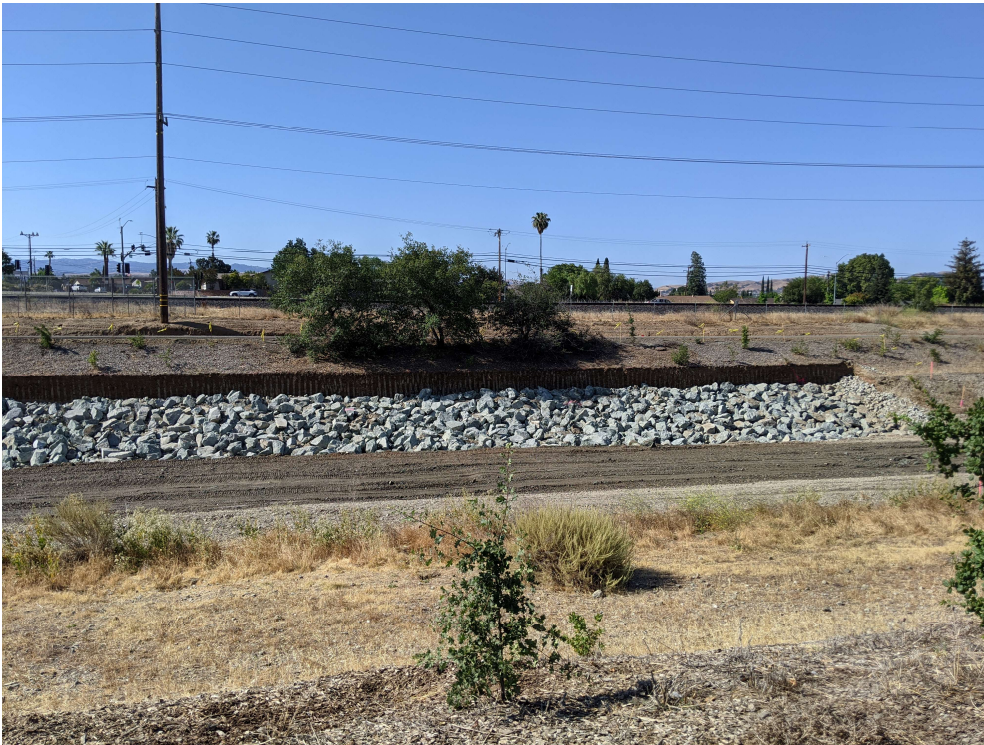
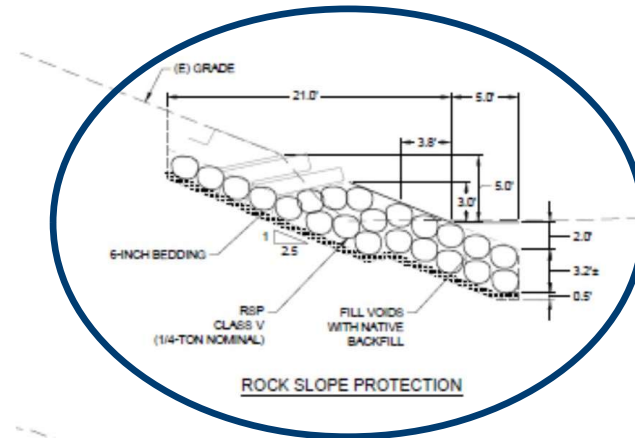
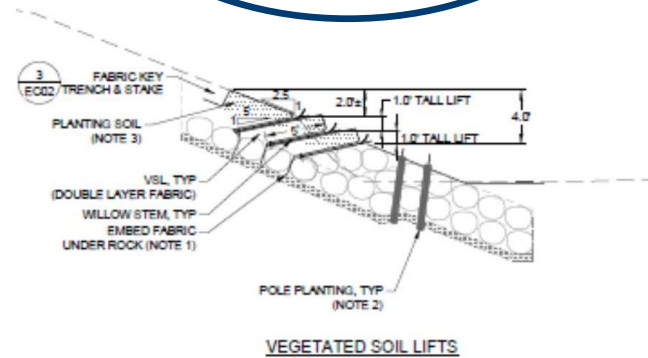
# Proposed RSP below planned Vegetated Soil Lifts at Site 3

2 VEGETATED SOIL LIFT WITH PLANTED ROCK TOE  
DETAIL SCALE: 1" = 5'

- Grade channel toe
- Install planted rock toe
- Install vegetated soil lifts and pole plantings
- 100% completion

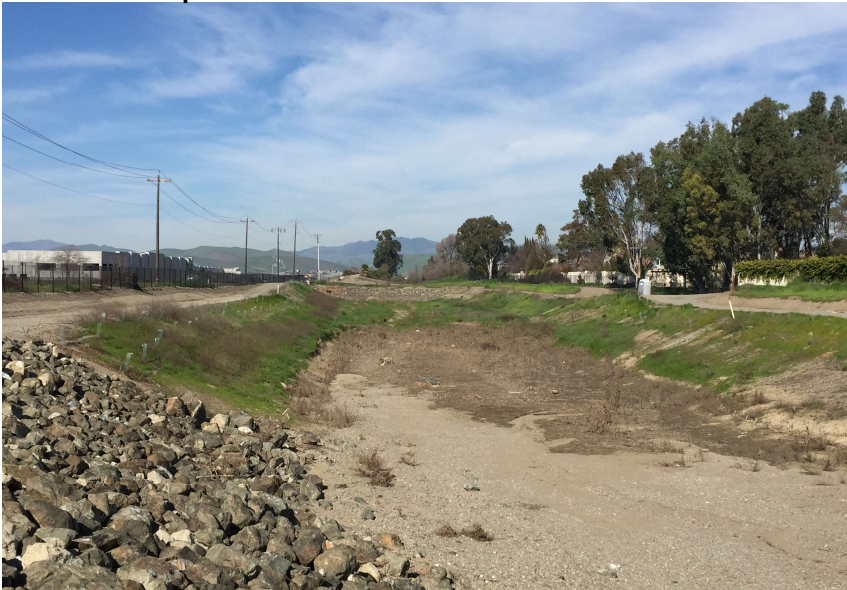
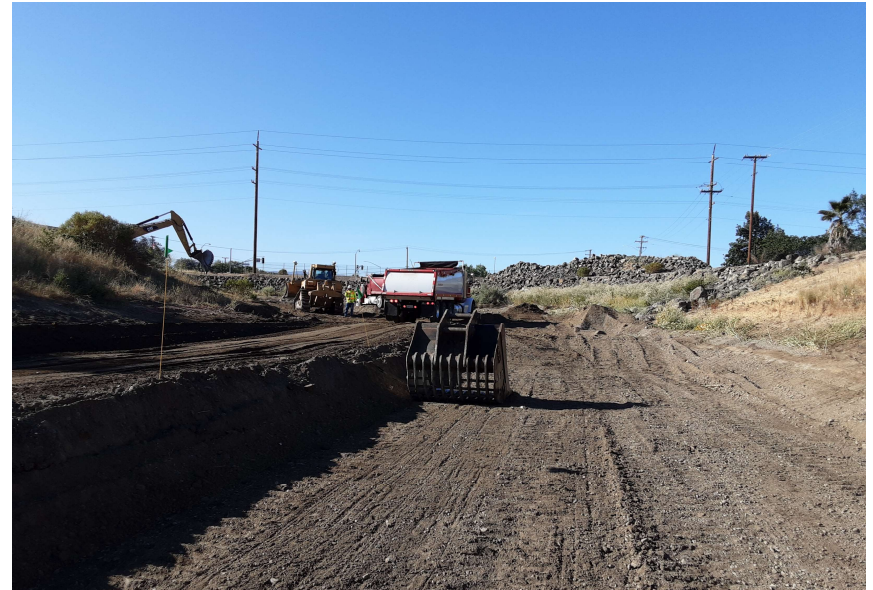
Pre-Construction

- Remove sediment
- Restore channel bank with rock slope protection
- 100% completion

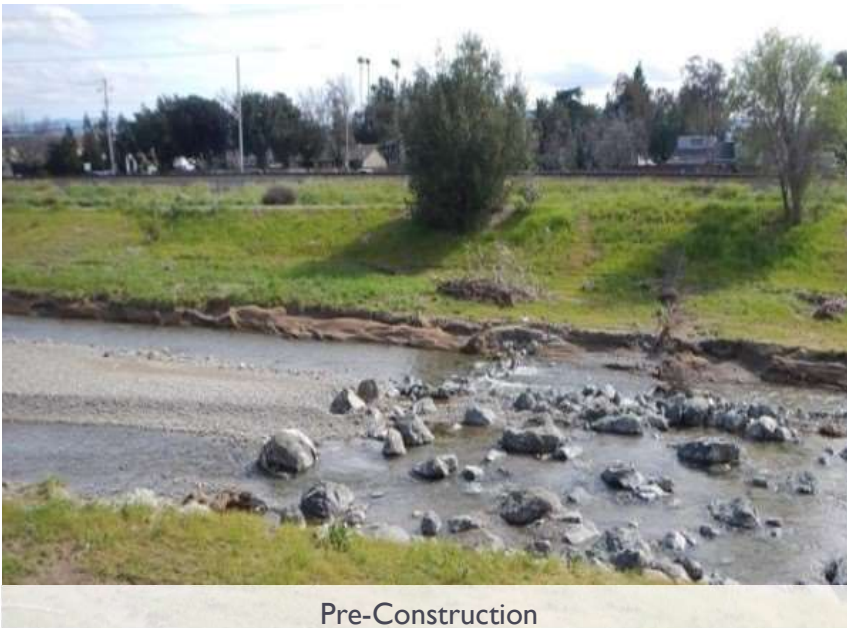
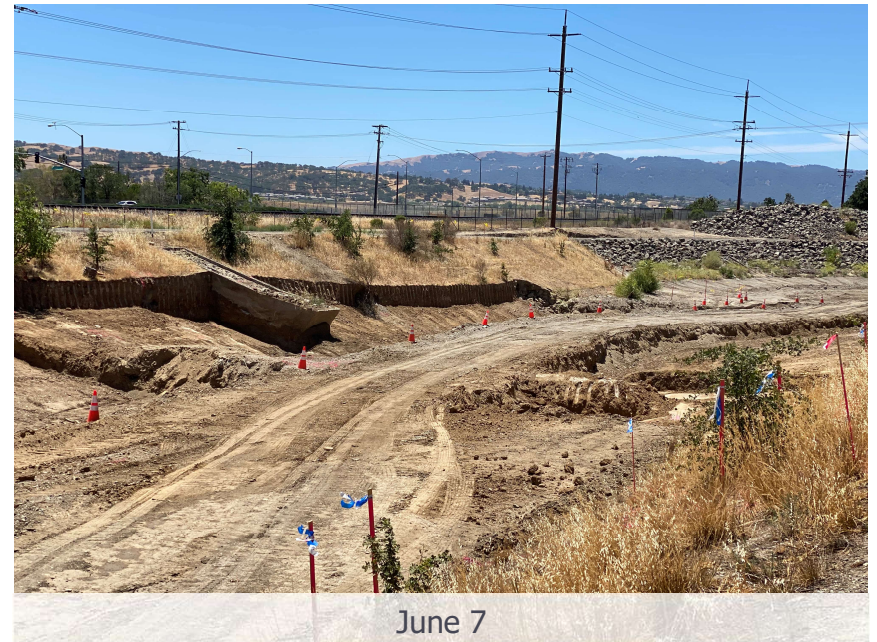
- Remove sediment and loose boulders
- Demo and reconstruct Roughened Channel #1 with rock slope protection
- 100% completion

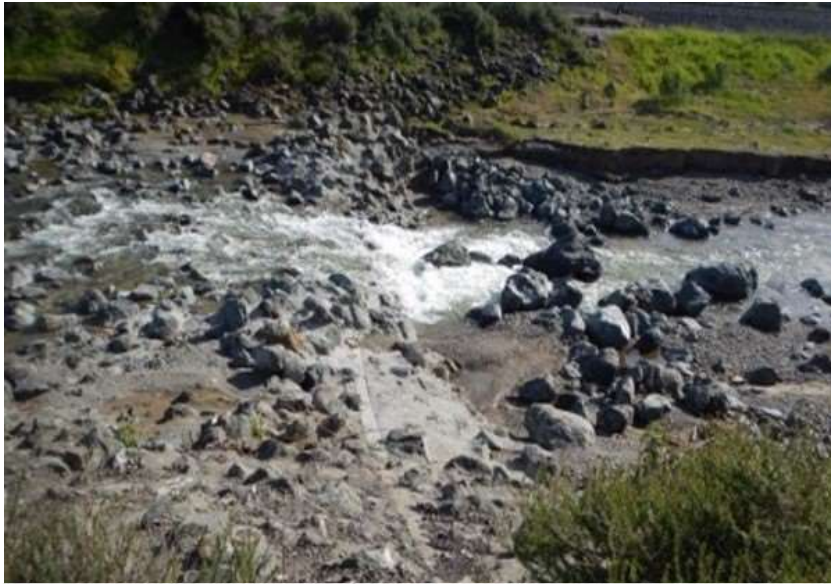
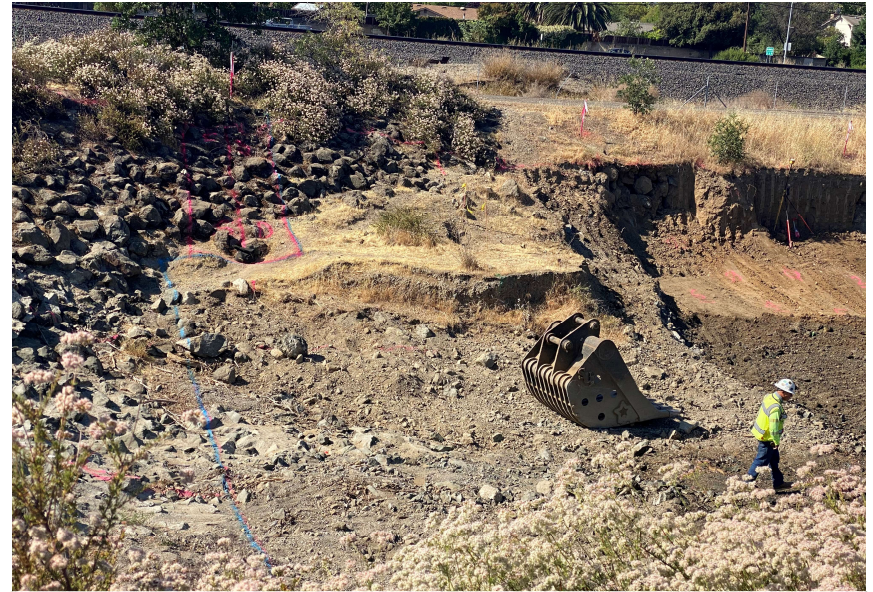
Pre-Construction

- Demo and reconstruct Roughened Channel #2
- 100% completion
